Safety Assessment

Whistle Cessation at Public Crossings

Adirondack Subdivision

Kahnawake, QC

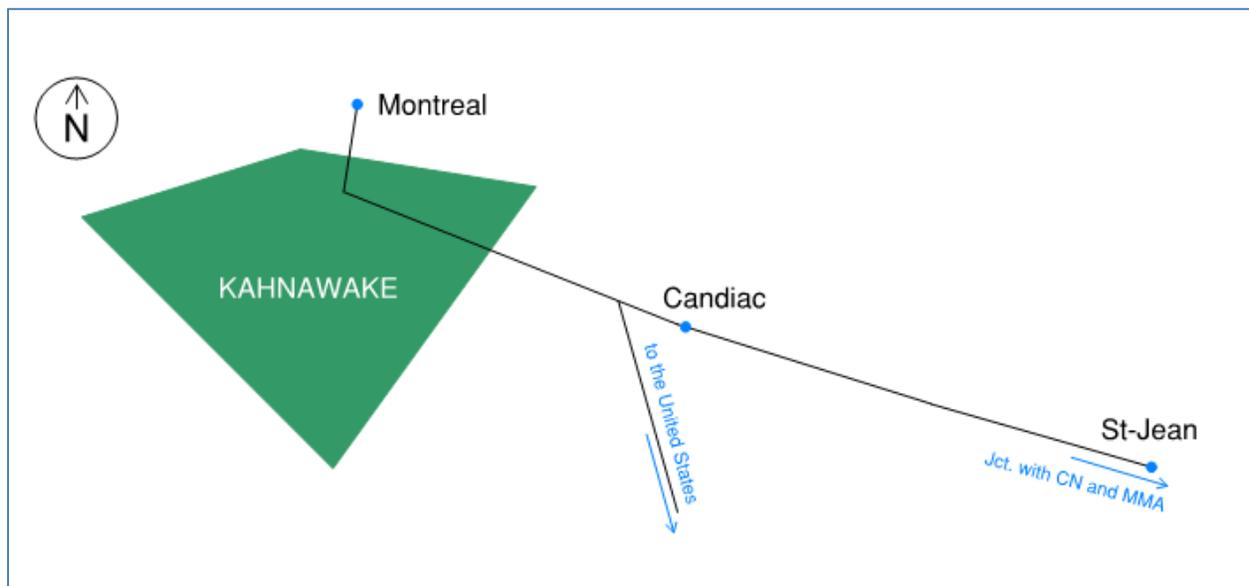
Figure 1A: Schematic Diagram showing CP corridor from Montreal

All three of these connections merge together and pass through Kahnawake to reach Montreal, as shown in Figure 1A.

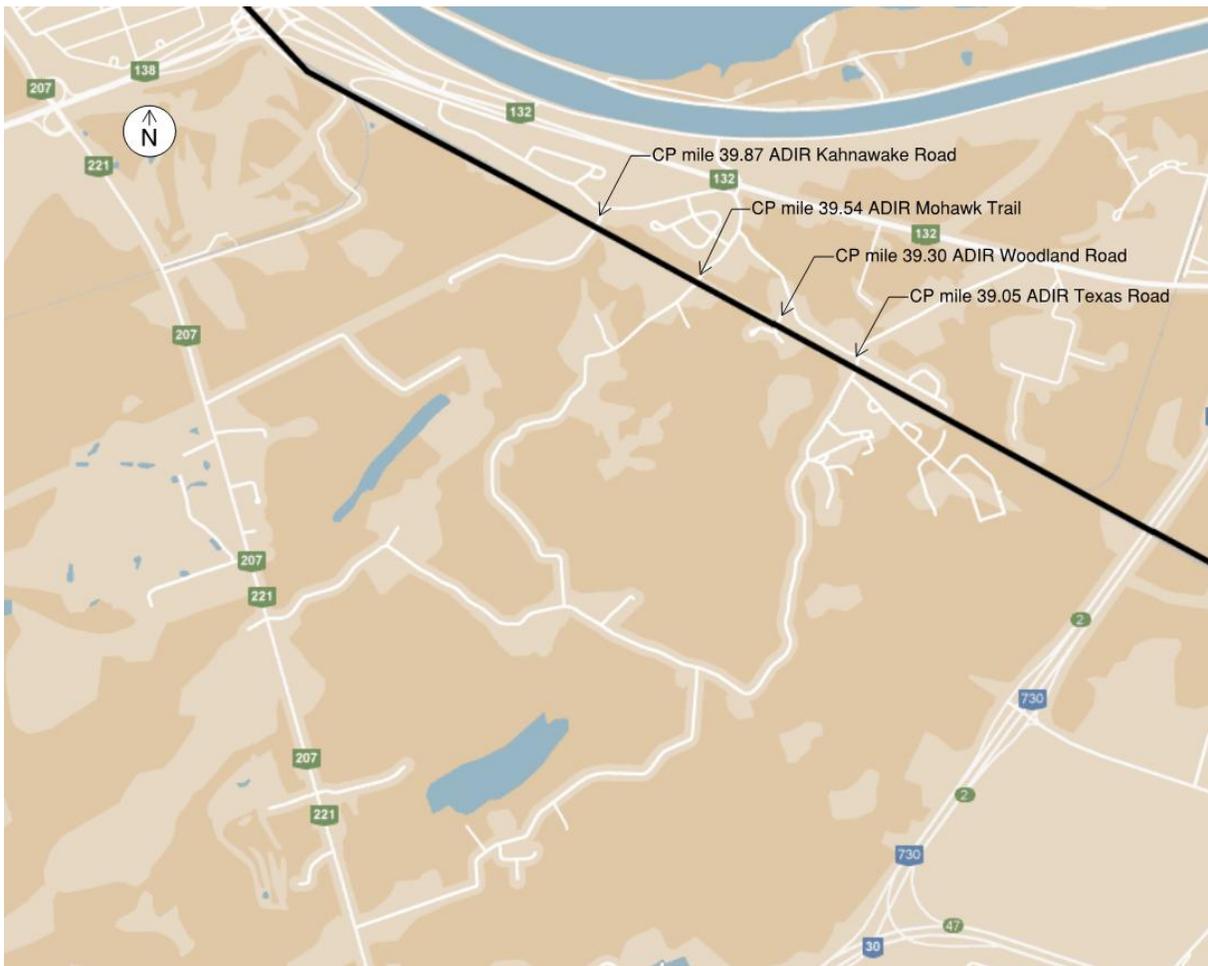
Figure 1B: Kahnawake Area Road Network

The Road Authority at each crossing is the Mohawk Council of Kahnawake. The population density around these crossings is relatively low. The territory is surrounded by many highways; 730, 30, 132, 207, and 138. The Texas Road and Mohawk Trail crossings are used primarily for local traffic. Some of the local roads connected to the crossings terminate in cul-de-sacs.

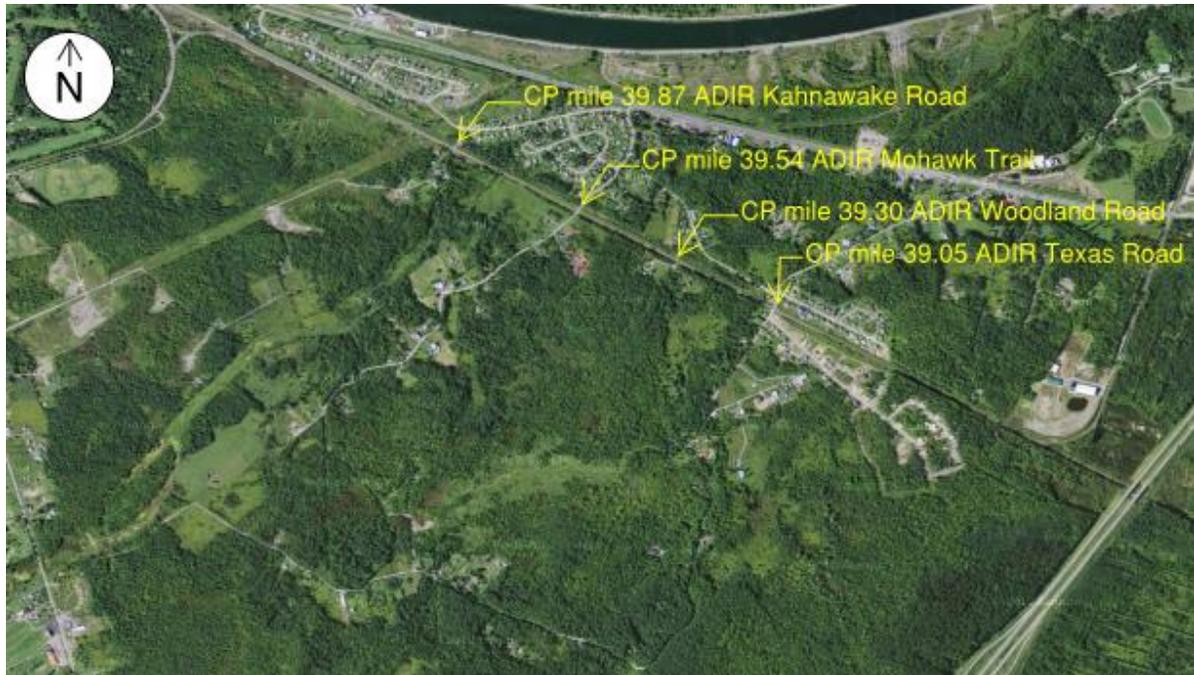
Figure 3A: Aerial photo showing the location of crossings

Four (4) crossings in Kahnawake Territory were inspected and additional crossing data was supplied by CP and the Mohawk Council of Kahnawake. Some general observations at each of the crossings are as follows:

- The CP mile 39.05 ADIR Texas Road crossing has a small residential area along the North-east and South-west sides of the crossing. The West side of the crossing does not have any houses.
- The CP mile 39.54 ADIR Mohawk Trail crossing has a large residential area to the North-west, with very few houses to the North-east. There is a school to the south of the crossing.
- The CP mile 39.87 ADIR Kahnawake Road crossing has a southerly road leading to a cul-de-sac lined with residential homes. North of the crossing, the area is sparsely populated both to the East and the West.
- The CP mile 39.30 ADIR Woodland Road crossing is located between Mohawk Trail and Texas Road and is used to access only two residential properties. The crossing is protected by cross-bucks, stop signs, and multiple track warning signs. Whistle cessation will not be pursued for this crossing.

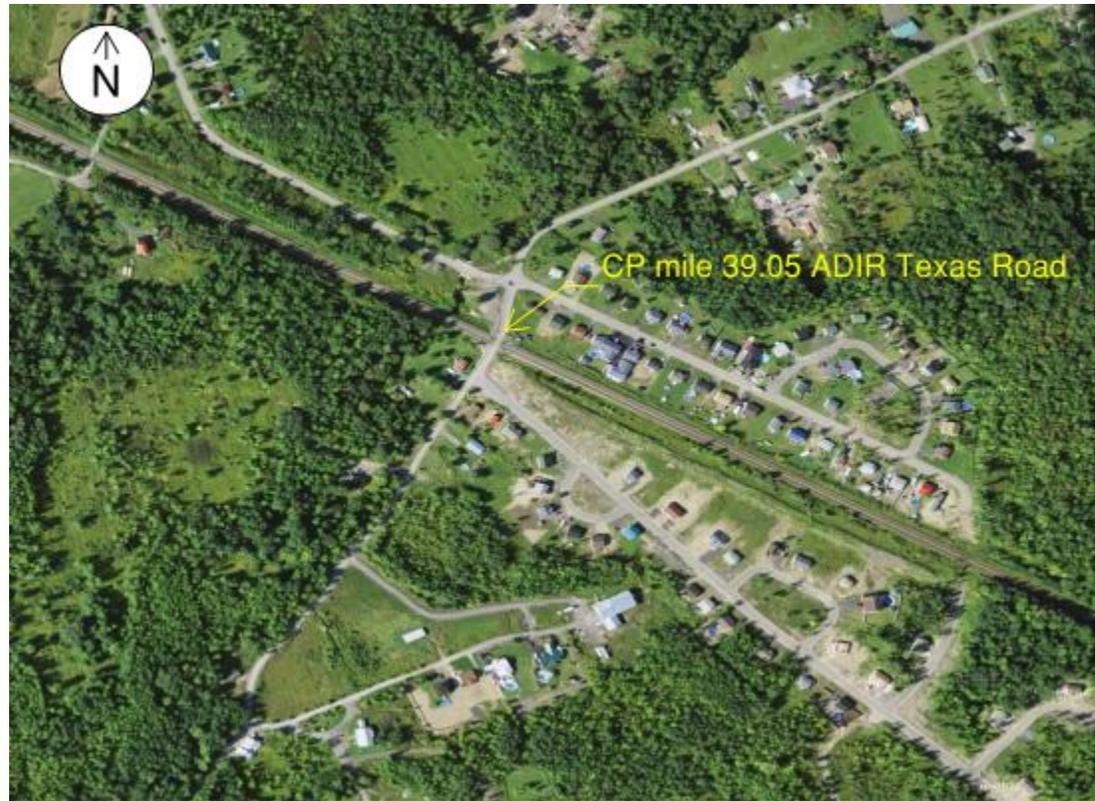
Figure 3B: Aerial photo showing CP mile 39.05 ADIR Texas Road Crossing

This is a crossing near an intersection approximately 60 metres away from the tracks. The crossing is in close proximity to the residential area to the East and has a memorial area to the North. On the South side, the closest residential home is approximately 30 metres from the tracks.

The crossing is frequently used by both vehicles and pedestrians throughout the day. A high volume of pedestrian traffic, crossing the track occurs in the morning and in the afternoon and is mostly predominantly children walking to and from the school located 915 metres away. Concrete barriers are on either side of the road to direct vehicle and pedestrian traffic over the crossing. These barriers also limit the width of the road.

From the site visit, there is no sign of intrusion onto the railway outside of the actual crossing. There is a fence that is in good condition along the residential houses in the North-east quadrant. When a vehicle is stopped 2 meters in front of the crossing warning devices, there are no obstructions blocking the line of sight along the track for a distance of 0.75 miles (1.2 km).

The surrounding area is expected to develop for future residential housing. Development will increase the population and effectively increase the use of the crossing. Another safety assessment should be conducted when appropriate, to evaluate the crossing safety with an increase in future traffic.

The crossing is missing stop lines on the roads and no trespassing signs at every track direction. There is a presence of ATV activity on the railway right-of-way. The ATV restriction signs are not present at the crossing.

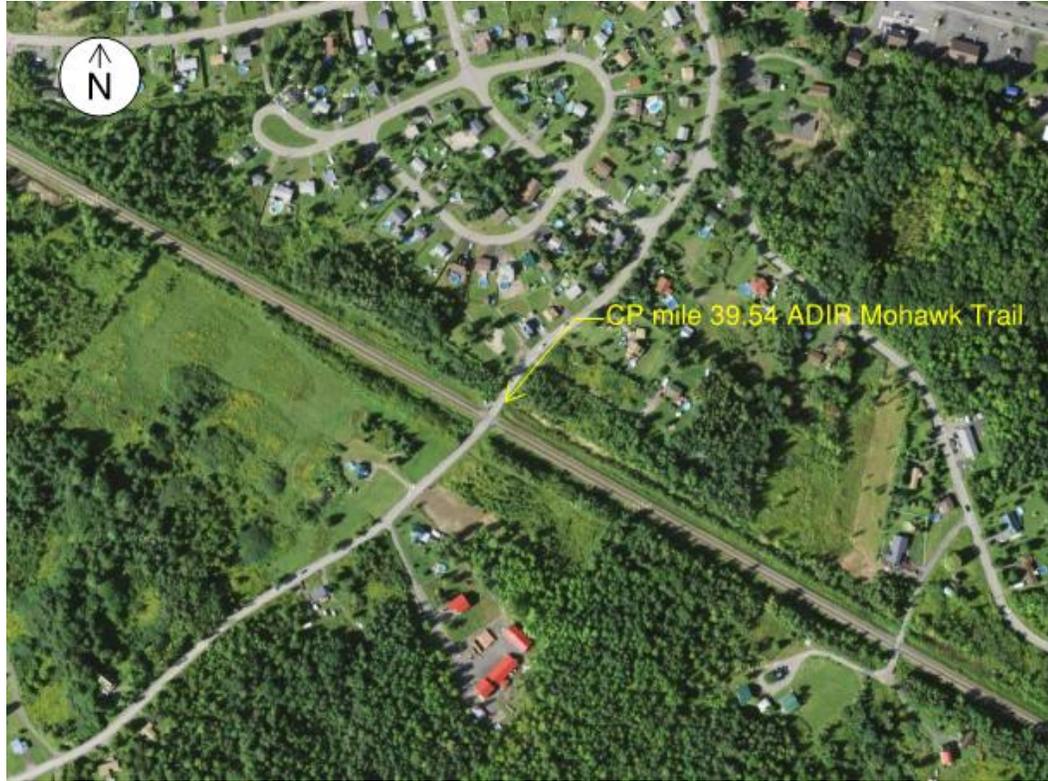
Figure 3C: Aerial photo showing CP mile 39.54 ADIR Mohawk Trail Crossing

An important observation at this crossing is the presence of the residential community to the North and the Indian Way School located approximately 480 metres South of the crossing. The crossing is heavily used during the morning and afternoon by school buses, community vehicles, and pedestrians. It is also noteworthy that there is a sports gym in the area and a children's playground is located approximately 46 metres north of the crossing.

There is no evidence of intrusion onto the railway outside of the actual crossing. There is a deep ditch along the North-east side of the tracks. When a vehicle is stopped 2 meters in front of the crossing warning devices, there are no obstructions blocking the line of sight along the track for a distance of 0.75 miles (1.2 km) in all directions. Vegetation was observed to be growing along the guy wire near the signal housing on the North-west side of the track.

The crossing is missing stop lines on the road and no trespassing signs in every track direction. There is a presence of ATV activity on the railroad territory. The ATV restriction signs are not present at the crossing.

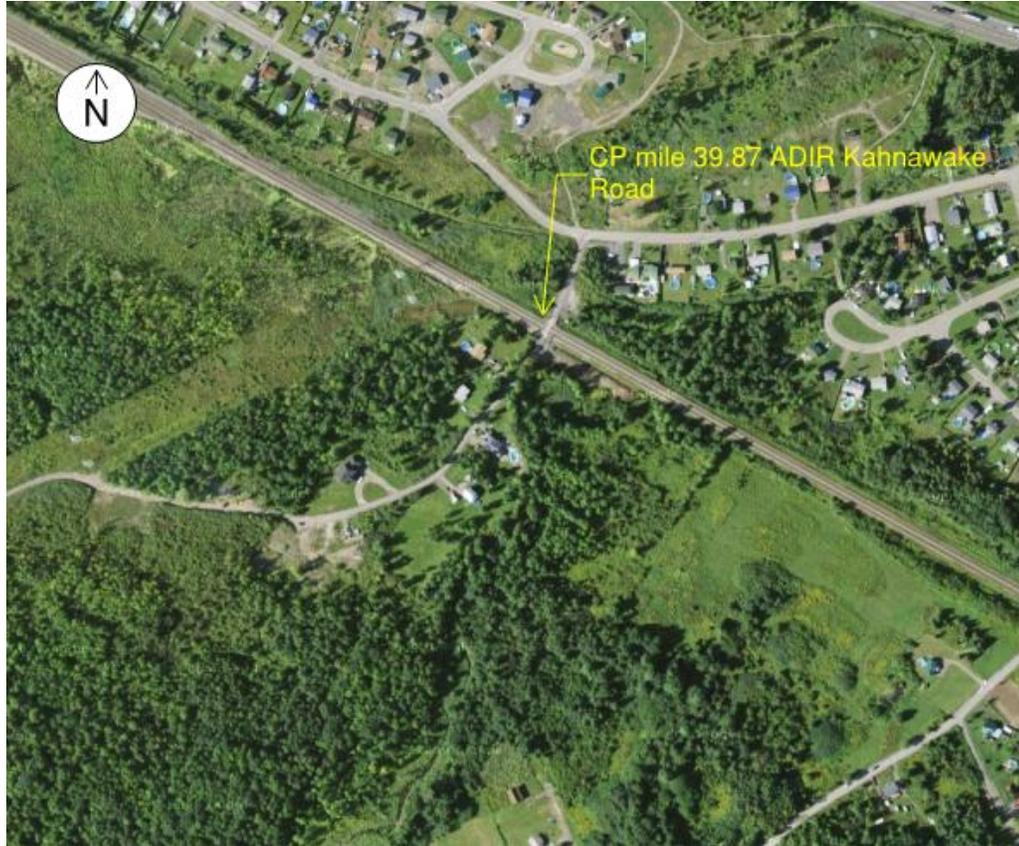
Figure 3D: Aerial photo showing CP mile 39.87 ADIR Kahnawake Road Crossing

There is a “T” intersection approximately 79 metres to the North of the tracks and the closest residential home is approximately 48 metres to the South. The road to the South of the crossing leads to a cul-de-sac with seven (7) residential houses. The crossing is used mostly in the morning and afternoon for school traffic. There is also a possibility of land fill trucks using the crossing. The road is situated on a crest and has concrete barriers on three sides of the road to prevent vehicles from crashing into the ditches.

There is no evidence of intrusion onto the railway outside of the actual crossing. There is a fence in the North-west quadrant that requires maintenance and repairs. When a vehicle is stopped 2 meters from the crossing warning devices, there are no obstructions blocking the line of sight along the tracks for a distance of 0.75 miles (1.2 km) in all directions.

The crossing is missing stop lines on the road and no trespassing signs at every track direction. There is a presence of ATV activity on the railroad territory. The stop sign at the North side is not required, when approaching the crossing the stop sign is blocking the view of the signal light. ATV restriction signs are not present at the crossing. There are no existing fences along the track to limit access through railroad propriety.

Also, the stop sign should be removed at the North side of the crossing approach. This crossing doesn't require a stop sign due to the presence automatic warning device. Also, when approaching the crossing, the stop sign is blocking the view of one the signal lights.

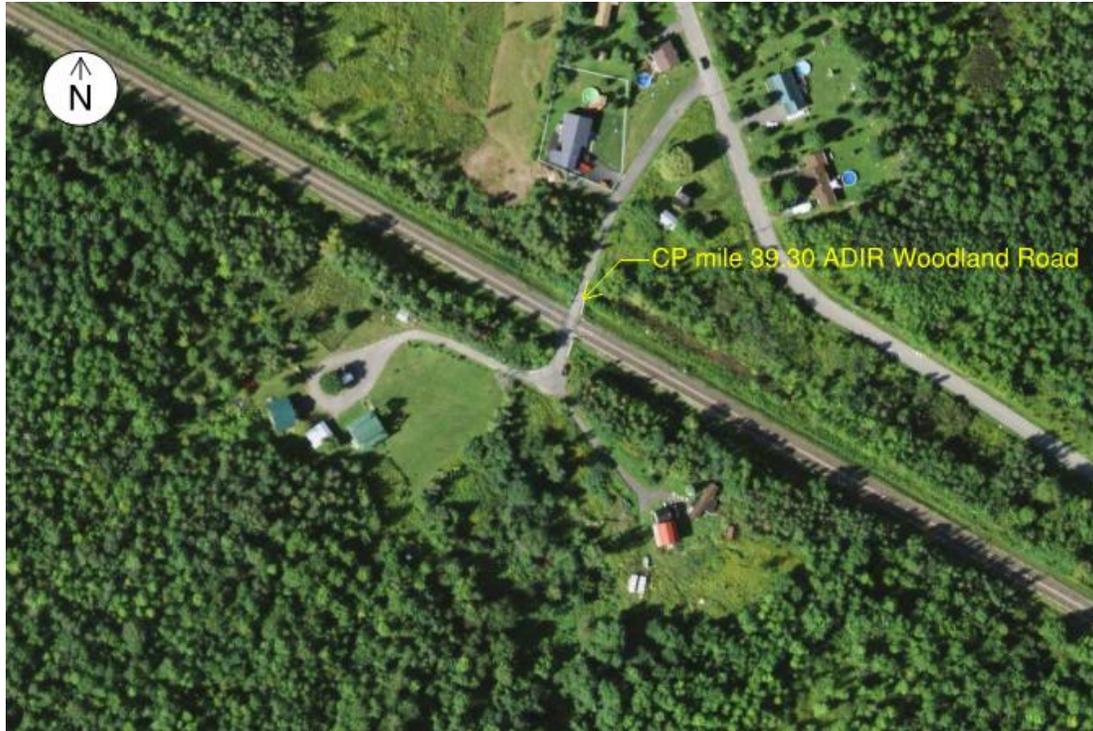
Figure 3E: Aerial photo showing CP mile 39.30 ADIR Woodland Road Crossing

The Woodland Road crossing will not be considered for train whistle cessation. The crossing is protected by cross bucks and a flagman (employee of the MCK) is on site from 06:00 hrs to 09:00 hrs and from 16:00 hrs to 19:00 hrs. The flagman protects the highest activity on the railway and on the roadway, including school bus movements.

- This road terminates in a cul-de-sac with a turnaround area adjacent to the South side of the tracks;
- There are only two (2) residences on the South side of the tracks;
- The crossing is accessible by way of a narrow road with concrete barriers on either side;
- Good visibility for sightlines in both directions; When a vehicle is stopped 2 meters in front of the crossing warning devices, there are no obstructions blocking the line

of sight along the track for a distance of 0.75 miles (1.2 km). Crossing signs and Stop signs are present and clearly visible;

- Second train signs are present; and
- This crossing lacks flashing lights, bells, and gates.

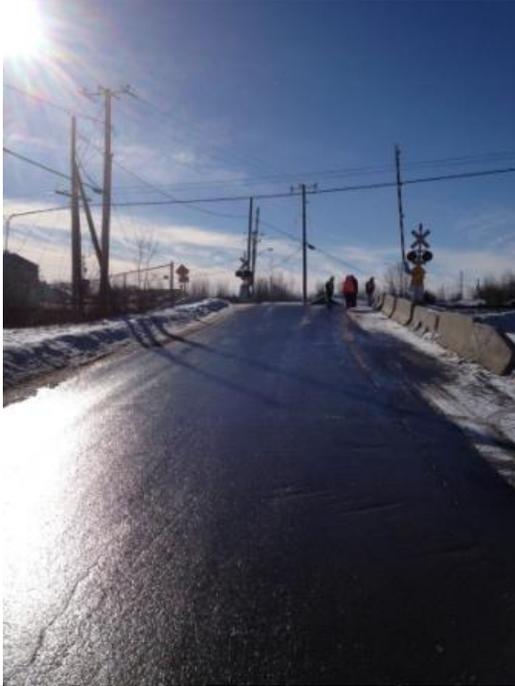
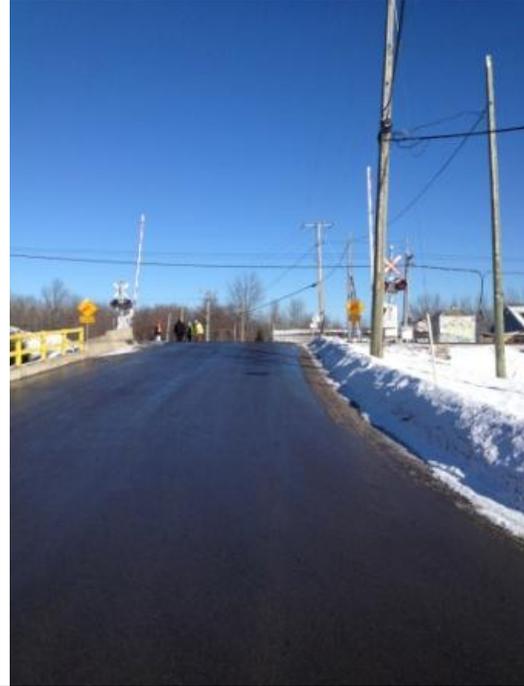
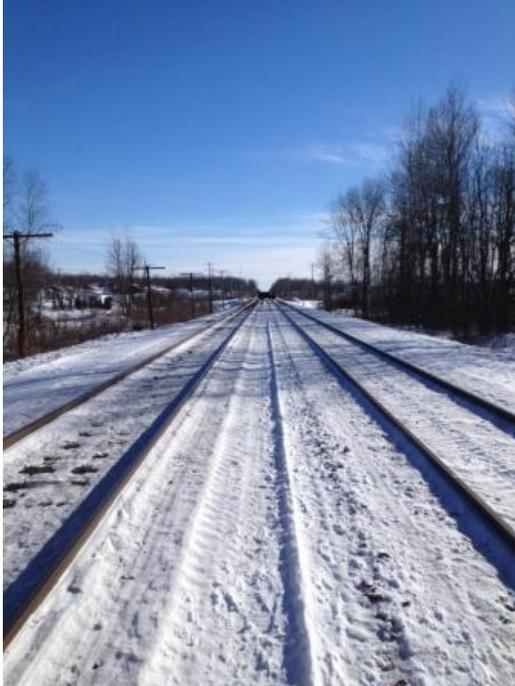
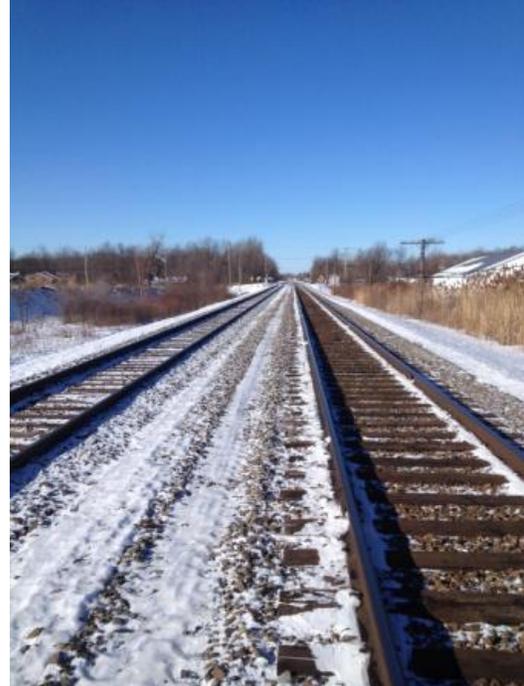
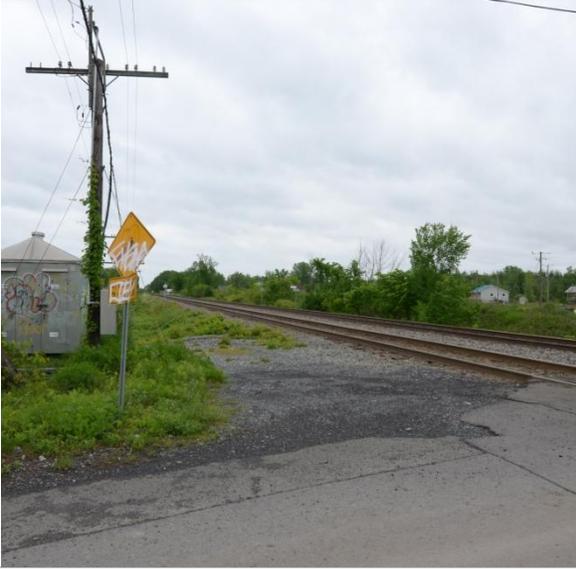
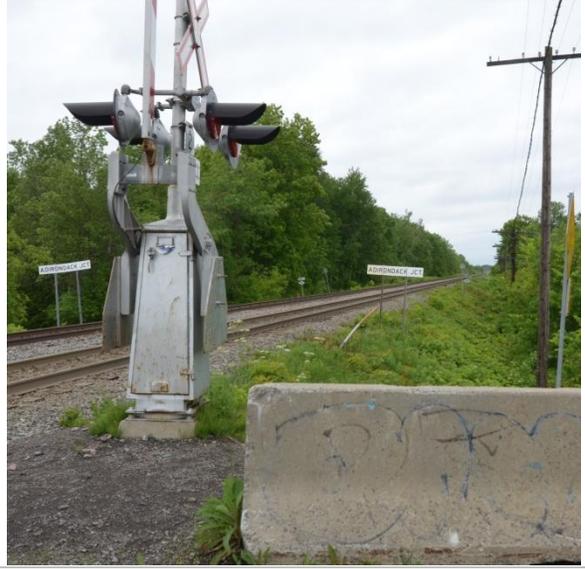
TC's Guideline		
Warning System Required due to train speed warrants. (50 mph – 2 tracks)	FLBG	Constant Warning time Automatic Warning Devices
Warning system condition		Good
Railway Advance Warning signs	WA-18	Missing
Guide Fencing (prevent going around the gate)		Not present
Additional signs, signals		2 nd Train signs
Pavement Markings		Stop Lines missing
Traffic signals within 30 m		NO
Queuing on the tracks		NO
There shall be no recurrent unauthorized access to the line of railway in the area:		<p>No signs of recurrent unauthorized access to the railway area. There are no signs of intrusion on either side of the road or either side of the tracks as per the June site visit.</p> <p>One ATV had run once or twice between the tracks several days prior to the inspection of January.</p> <p>Trespassing is prevalent in the area. Both pedestrian and ATV intrusions have been reported to be common. This would be from one crossing to the adjacent.</p>

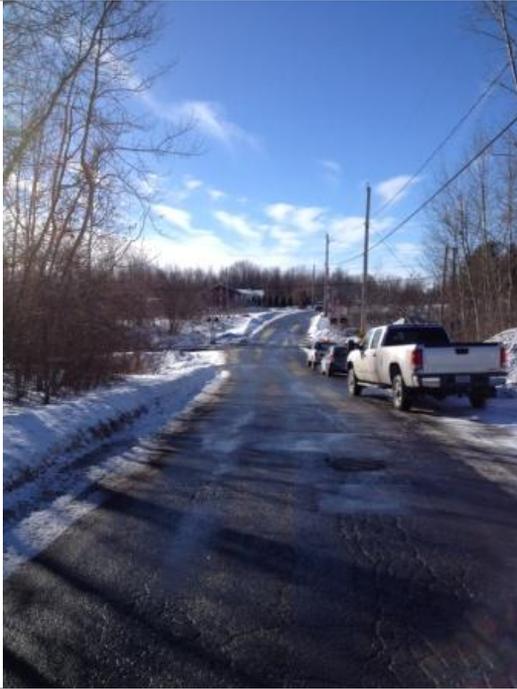
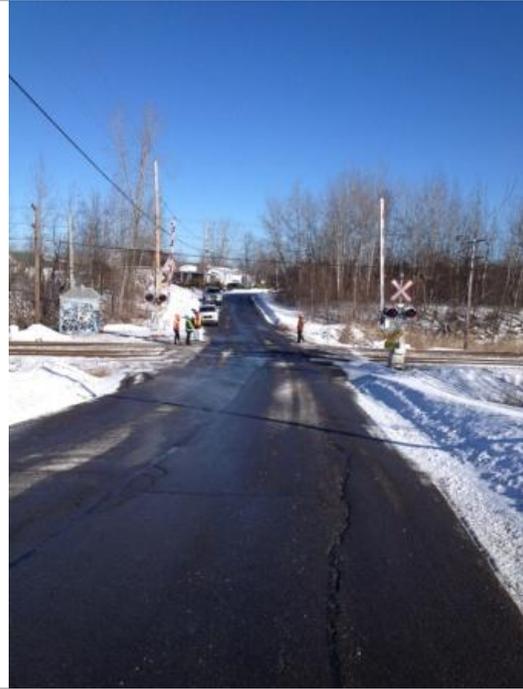
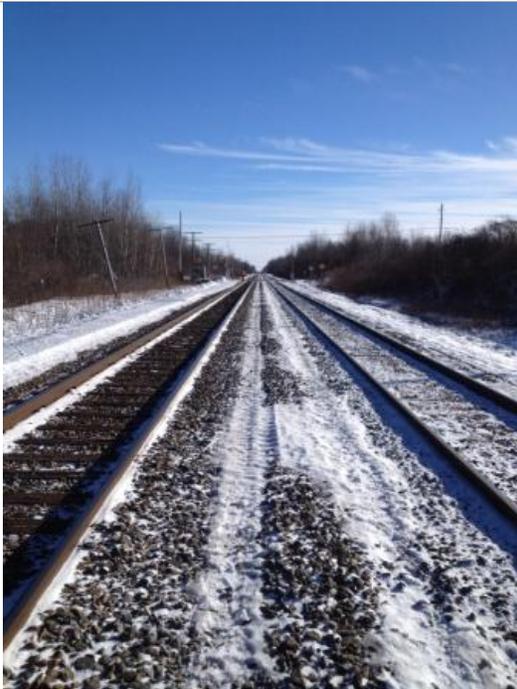
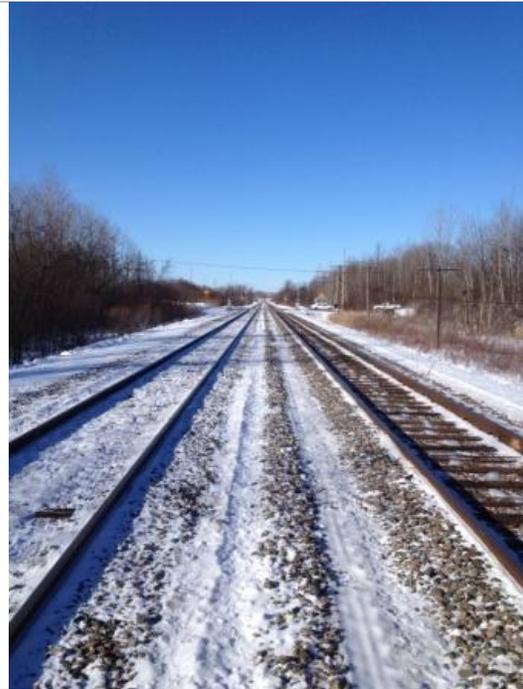
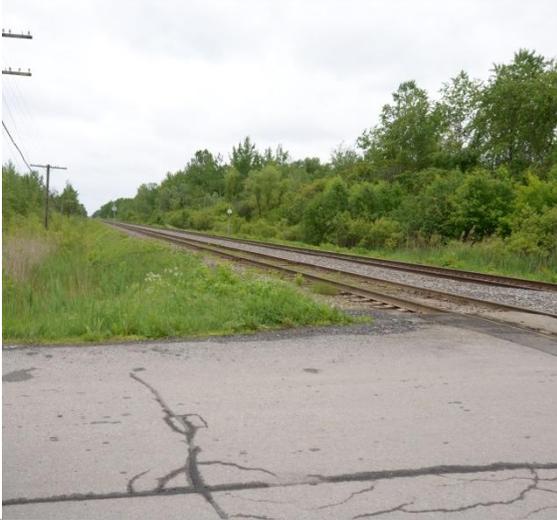
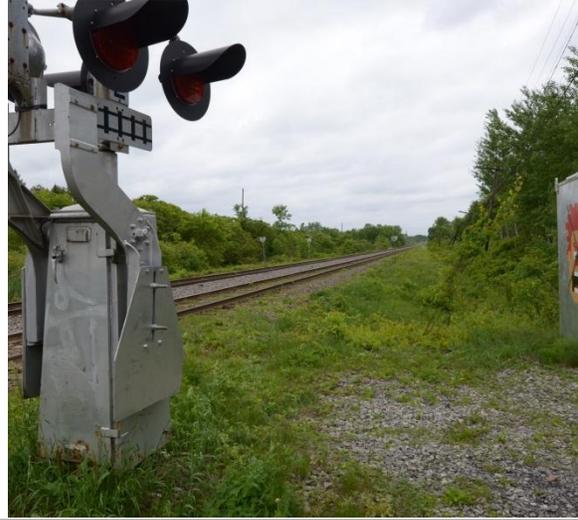
TC's Guideline		
Warning System Required due to train speed warrants. (50 mph – 2 tracks)	FLBG	Constant Warning time Automatic Warning Devices
Warning system condition		Good
Railway Advance Warning signs	WA-18	Not installed
Guide Fencing (prevent going around the gate)		N/A

Additional signs, signals		2 nd Train signs
Pavement Markings		Stop Lines missing
Traffic signals within 30 m		NO
Queuing on the tracks		NO
There shall be no recurrent unauthorized access to the line of railway in the area:		<p>No signs of recurrent unauthorized access to the railway area. There are no signs of intrusion on either side of the road and either side of the tracks as per the June site visit</p> <p>One ATV had run once or twice between the tracks several days prior to the inspection of January.</p>

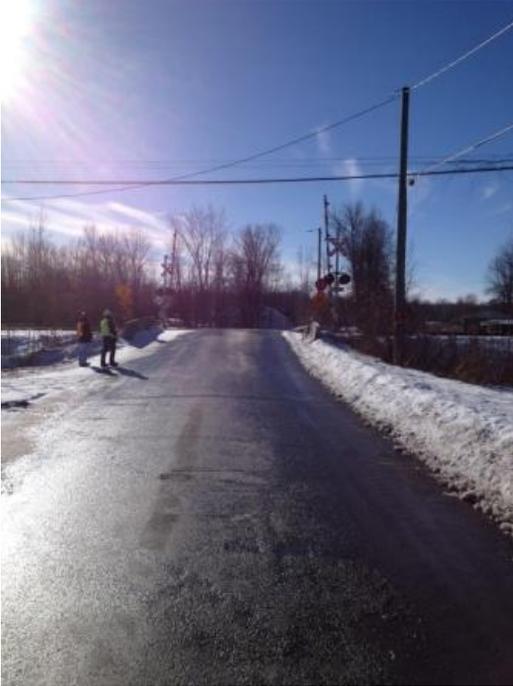
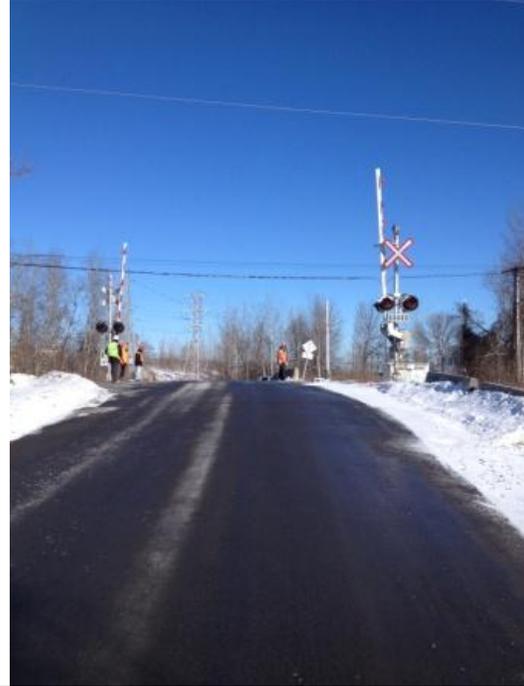
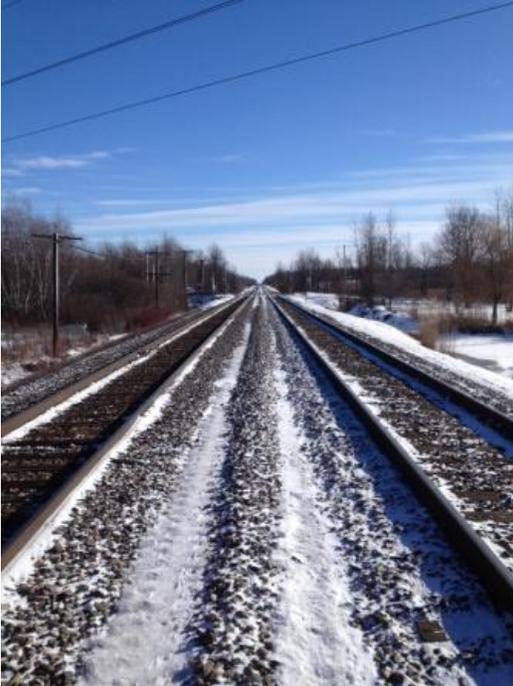
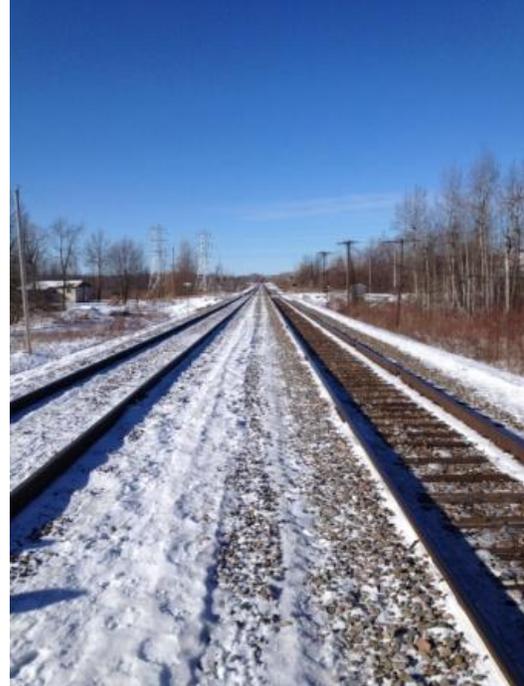
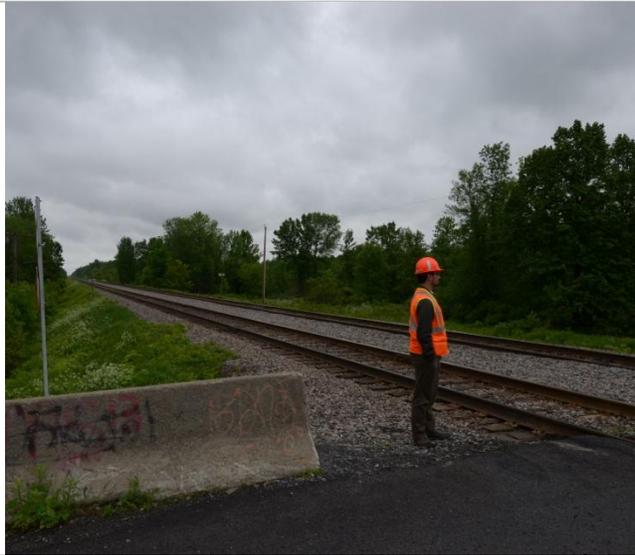
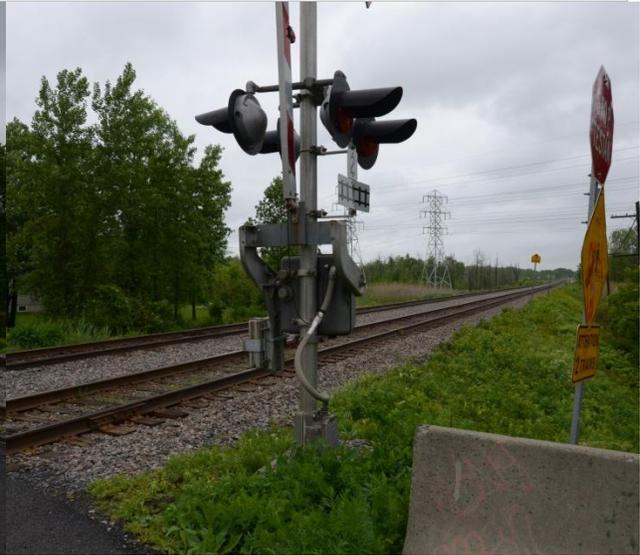
TC's Guideline		
Warning System Required (50 mph – 2 tracks)	FLBG	Constant Warning time Automatic Warning Devices
Warning system condition		Good.
Railway Advance Warning signs	WA-18	Not installed
Guide Fencing (prevent going around the gate)		Not present
Additional signs, signals		2 nd Train signs Stop sign on the North side
Pavement Markings		No Stop Lines painted on the travelled surface
Traffic signals within 30 m		NO

Queuing on the tracks		NO
There shall be no recurrent unauthorized access to the line of railway in the area:		<p>No signs of recurrent unauthorized access to the railway area. There are no signs of intrusion on either side of the road and either side of the tracks as per the June site visit</p> <p>One ATV had run once or twice between the tracks several days prior to the inspection of January.</p>

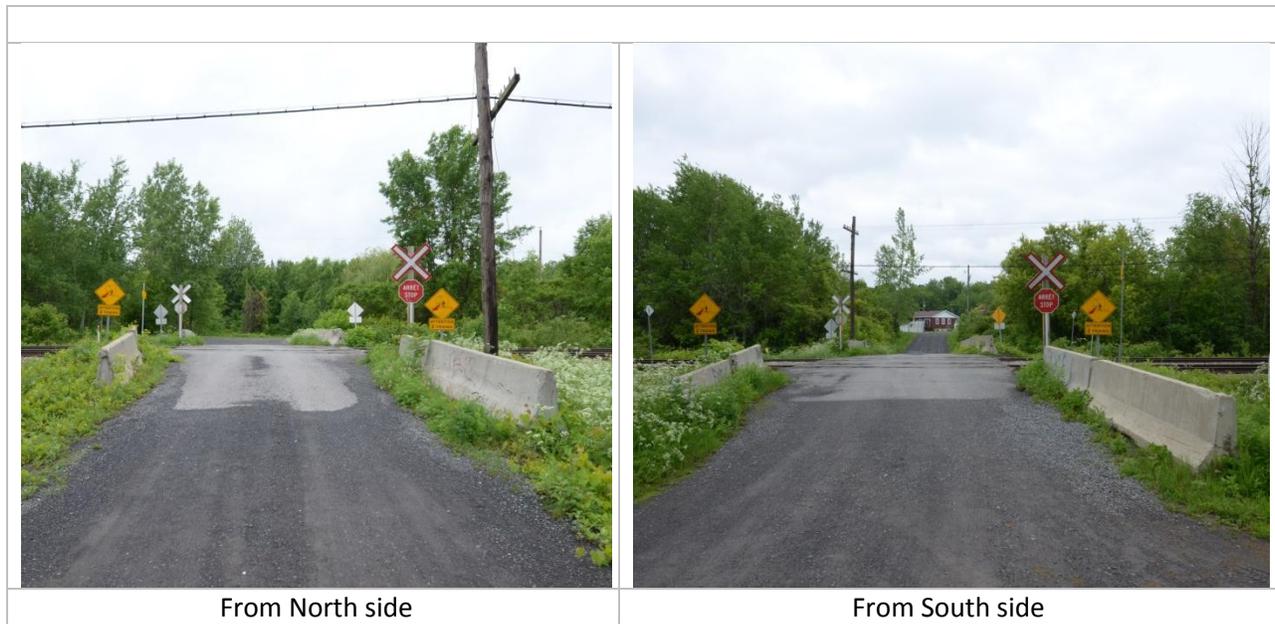
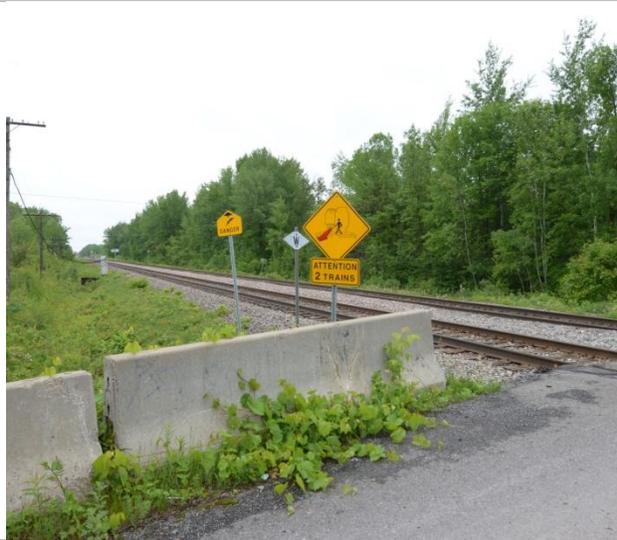
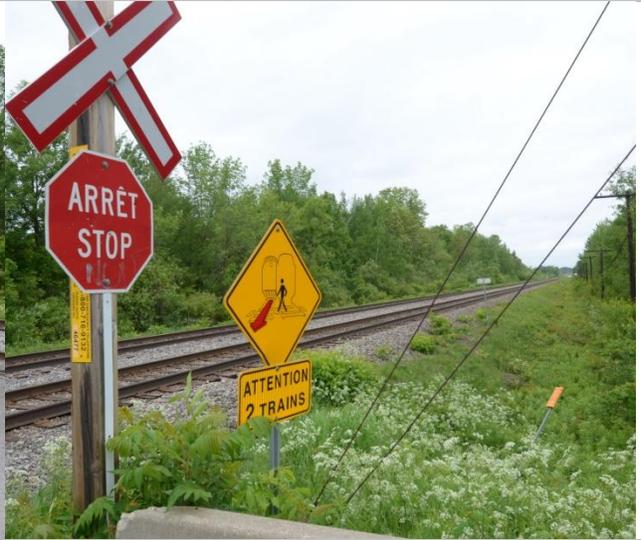
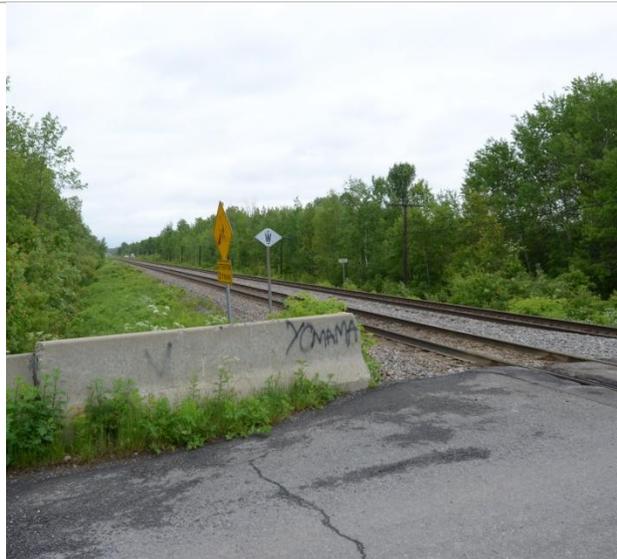
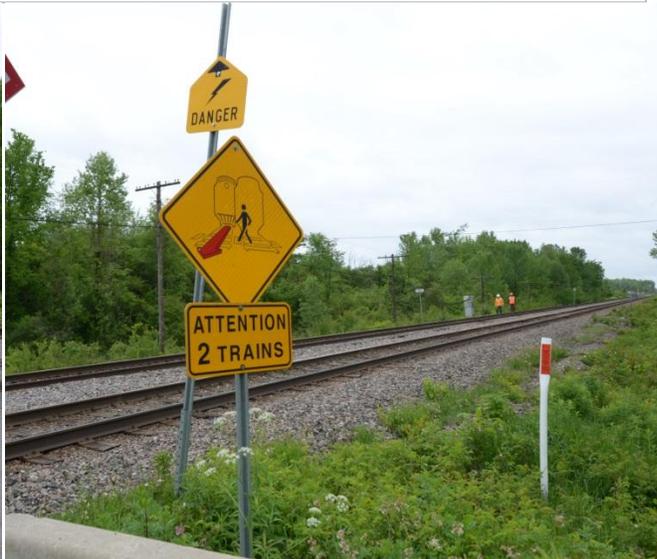
TC's Guideline		
Warning System Required due to train speed warrants (50 mph – 2 tracks)	FLBG	No AHWD
Warning system condition		Good

Railway Advance Warning signs	WA-18	Not installed
Guide Fencing (prevent going around the gate)		n/a
Additional signs, signals		2 nd Train signs
Pavement Markings		No Stop Lines painted on the travelled surface
Traffic signals within 30 m		NO
Queuing on the tracks		NO
There shall be no recurrent unauthorized access to the line of railway in the area:		n/a
